# EXHIBIT E – SCENIC AREAS, HISTORIC SITES AND STRUCTURES, AND ARCHAEOLOGICAL SITES

# CULTURAL RESOURCES ASSESSMENT FOR TUCSON ELECTRIC POWER'S

NOGALES TAP TO KANTOR TRANSMISSION LINE PIMA AND SANTA CRUZ COUNTIES, ARIZONA

# A CLASS III CULTURAL RESOURCES SURVEY FOR THE UNISOURCE NOGALES TAP TO KANTOR TRANSMISSION LINE, PIMA AND SANTA CRUZ COUNTIES, ARIZONA

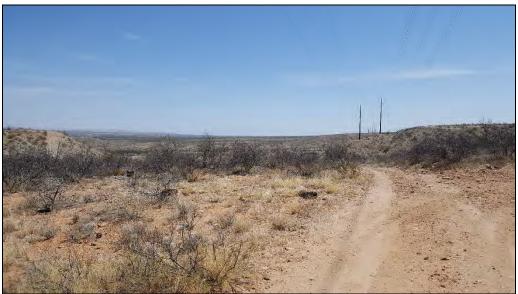
Figure 13 Overview of AZ DD:8:261(ASM), facing north.

**SITE DESCRIPTION:** AZ DD:8:261(ASM) consists of a surface scatter of historic period artifacts which represents a historic dump (waste pile) site. Temporally diagnostic historic artifacts identified during field survey range from the 1930s to the 1950s (**Table 9**). Chronology is based mostly on glass bottle makers' marks and can manufacturing technology. There are two primary concentrations of artifacts. The largest (Feature 1) is at the site's north end near the edge of a north-sloping ridge. This concentration contains the majority artifacts and is approximately 10 meters (32 feet) diameter. The smaller concentration (Feature 2) is at the south end. Feature 2 is approximately 8 meters (26 feet) diameter. Approximately 400 artifacts are spread over the site surface. Artifacts present at the site include approximately 200 glass, 100 metal, and 50 ceramic artifacts along with wood and other miscellaneous types of artifacts. Glass artifacts consist of bottle glass shards (clear, amber, green, and blue glass). Most of the small bottle glass shards are within Feature 1 and likely represent soda and beer bottles. Metal artifacts are mostly represented by tin cans, along with miscellaneous brackets, bolts, and hardware. Historic ceramics at the site include white porcelain and earthenware. These ceramics are all located in Artifact Concentration No. 1.

**Site Condition**: The site is in poor to fair condition. Most glass shards are too small and fragmented to hold any information potential. Modern trash (1970s to present) has also been deposited in the area, and thus many of the glass and metal objects within the site boundary cannot be reliably dated.

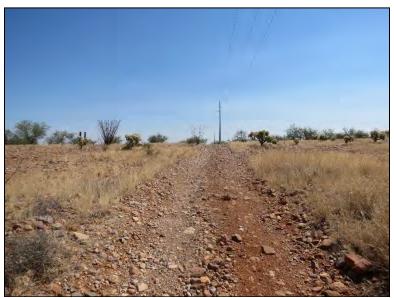
Figure 14 Overview of AZ EE:1:167(ASM), facing north.

SITE CONDITION: No portion of the site is present within the project area. During the archaeological testing project in 1989, half of the surface artifacts were collected from within the 100-ft-wide project area easement (corresponding to the current project area). No artifacts were observed within the project area in the current project. The site is currently in very poor condition. Only a few lithic artifacts are present outside of the current project area and within the previously recorded site boundaries. The site's location on a south-sloping ridge has likely caused severe erosion of site. Sheet erosion and small rills are evident on the site's sloping surface. Many of the site's surface artifacts may have washed down into this drainage.

**ARHP AND NRHP ELIGIBILITY EVALUATION:** This site has not been formally evaluated by SHPO and no recommendation has been made regarding State and National Register eligibility. The site no longer retains integrity as there are no cultural materials currently present on the ground surface. Furthermore, previous data recovery has exhausted the research potential at AZ EE:1:167(ASM). The site is recommended as ineligible for the Arizona and National Register of Historic Places.

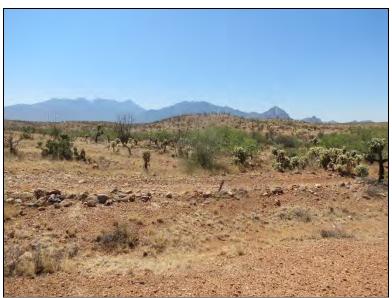
Figure 15 Overview of AZ EE:1:168(ASM), facing southeast.

**SITE INTERPRETATION:** This site was originally described as a diffuse lithic scatter. Features included two surface rock clusters. Lithic tools recorded during the original survey included two choppers, a large biface fragment, a projectile point fragment, and a scraper. Most lithics were made of low grade cream colored and light gray chert, with smaller amounts of quartz, basalt, and quartzite. All material was very low grade. Based on the previous subsurface test excavations, artifact collection, and artifact analysis, the site was determined to be a lithic scatter limited to the ground surface (Fennicle et al. 1989). Analysis of lithic artifacts illustrated that both tool production and core reduction was conducted at the site (Fennicle et al. 1989:14).

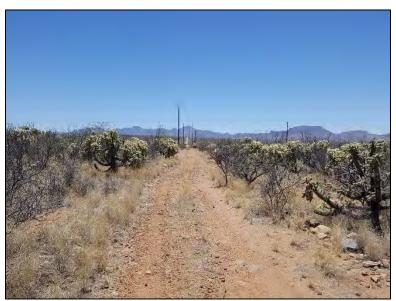
Figure 16 Overview of AZ DD:8:138(ASM), facing south.

**SITE DESCRIPTION**: AZ DD:8:138 consists of a very large, widely dispersed lithic scatter. Surface artifacts observed within the site during the current project were primarily outside the project area. Less than a dozen lithic artifacts were identified within the current project area- all flaked stone debitage of medium grained igneous material. In the original recording of the site (Bruder and

SITE CONDITION: A paved road (South Mt. Hopkins Road) runs approximately southeast-northwest through the site. The current transmission line, access road, and former 1958 transmission line (AZ DD:8:259[ASM]) also cut directly through the site. Previous surface collection of artifacts and subsurface investigations with the project area easement have directly affected the site condition within this portion of the site boundaries. Only a few artifacts were observed within the current project area due to the previous artifact collection. Accordingly, the portion of the site with the project area is in poor condition and lacks integrity.
